ABC Ethanol, Our Town, NE Vibration Analysis Condition and Recommendations Summary

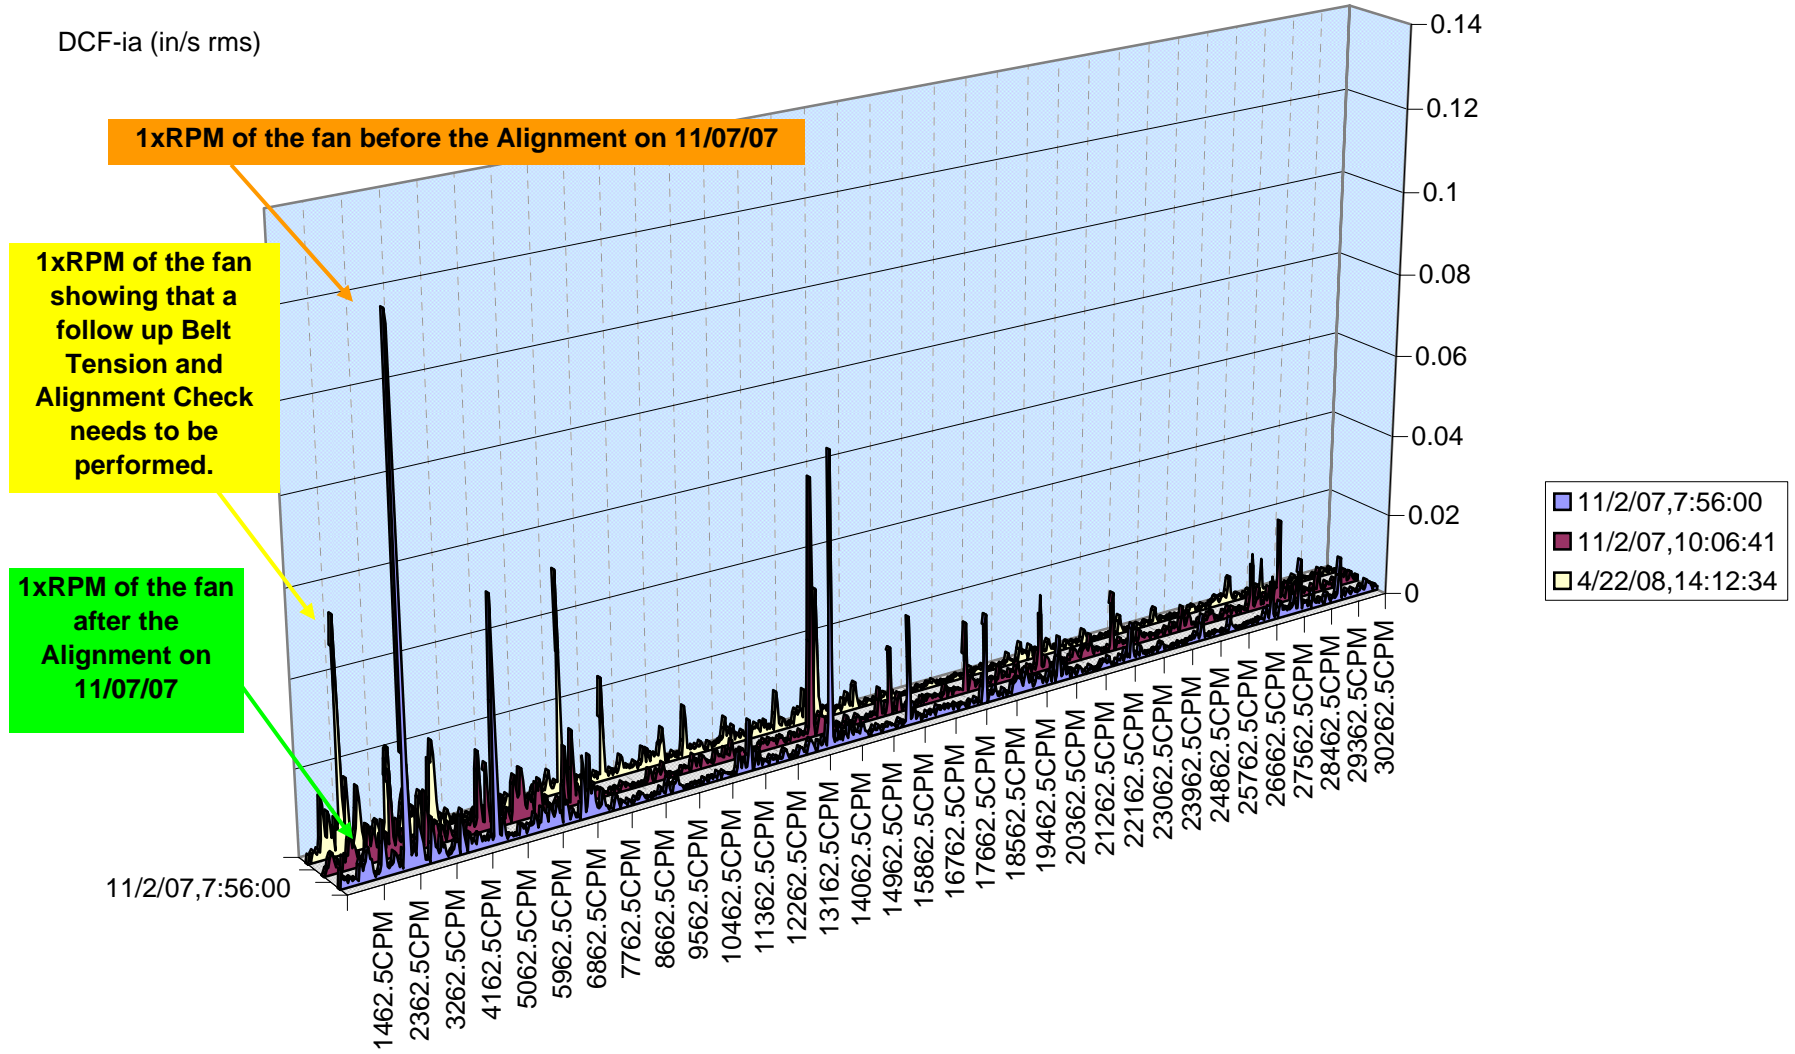
Waterfall Graph of VA Fan DCF-ia

Area	Equipment ID	Fault	Priority	Findings	Recommendation	Repair Notes	Date Repaired	Next Reading
Energy Plant	VA Fan	Motor Belt Issues / Loose Fan Bearings	Repair within the month	Both in the heat present and the vibration indicate the belt tension is improper.	Lubricate bearings and continue to monitor the fan bearings for changes.			May 2009
Energy Plant	VA Comb Fan Motor	Normal Operation	No Action Required	Normal Vibration Levels Present	Continue normal monitoring			May 2009
Energy Plant	ID Comb Fan	Misalignment across the coupling	Repair within the quarter	Vibration shows high 2xRPM in horizontal direction which indicates a misalignment	Have a laser alignment performed to reduce the loading on the bearings			May 2009
Energy Plant	East Jordan	Normal Operation	No Action Required	Normal Vibration Levels Present	Continue normal monitoring			May 2009
Energy Plant	West Jordan	Looseness on Drive end Motor Bearing	Monitor Closely	Motor shows multiple harmonics of turning speed with advanced bearing analysis	Closely monitor the operating condition of the West Jordan and Motor until next readings			May 2009

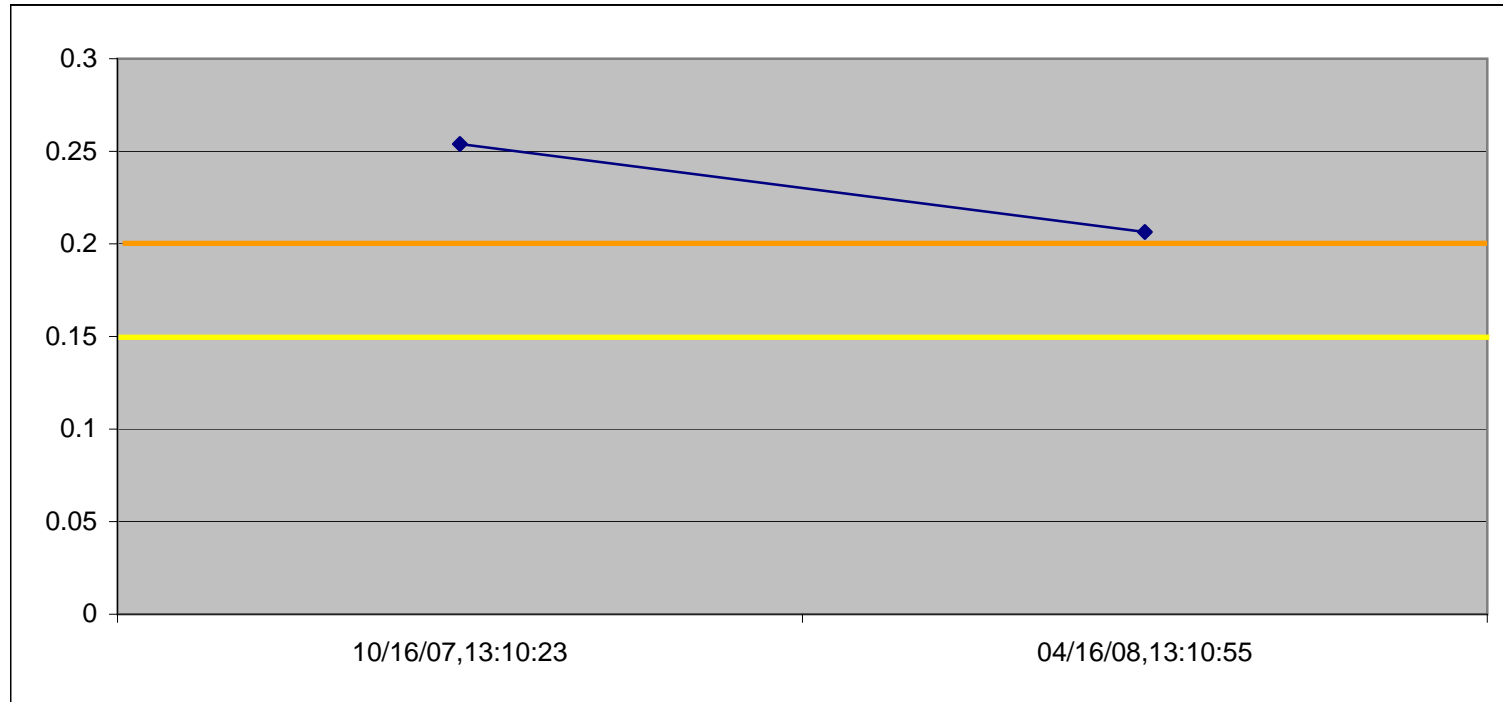
INSPECTION POINT TREND REPORT of ID Comb Fan pia2419

<u>Date/Time</u>	<u>Value</u>	<u>Units</u>	<u>Severity</u>
10/16/07,13:10:23	0.253952	in/s rms	Critical
04/16/08,13:10:55	0.20639	in/s rms	Warning

Vibration Levels have decreased slightly but are still above the recommended limited use levels. Recommend a laser alignment be performed.

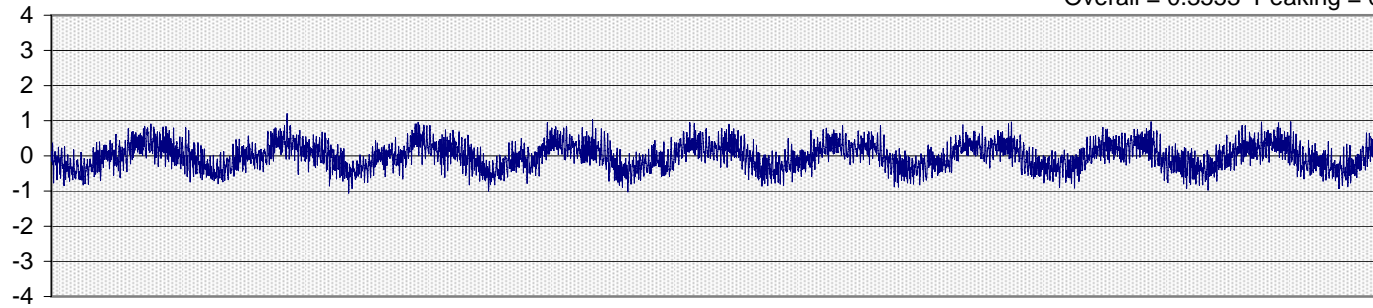
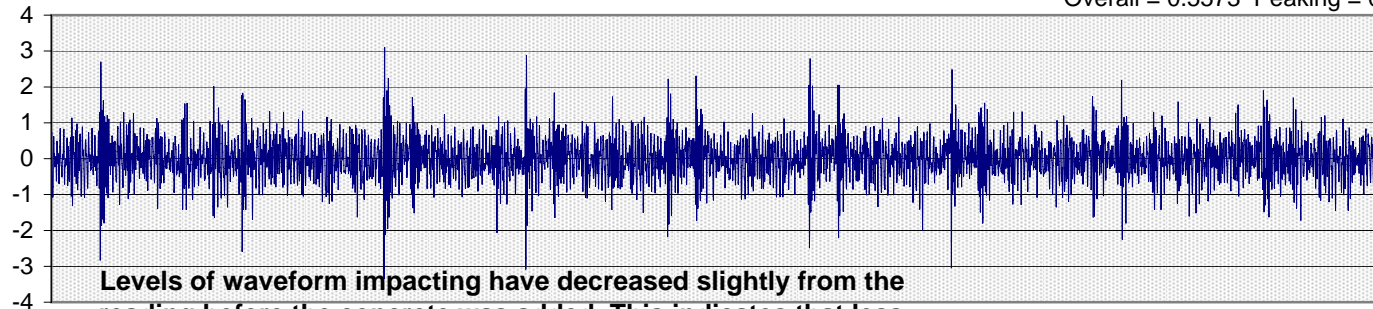
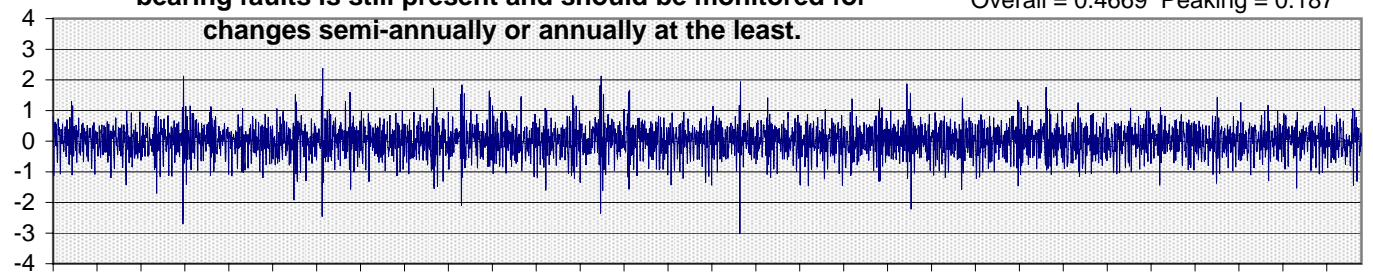
Levels of waveform impacting have decreased slightly from the reading before the concrete was added. This indicates that less stress is on the motor bearings but the presence of inner race bearing faults is still present and should be monitored for changes semi-annually or annually at the least.
